## INDEPENDENT INSPECTION REPORT

# Peugeot 2008

Approx. 121.000 km · October 2026

Inspected by Carvise · Reviewed by Carvise

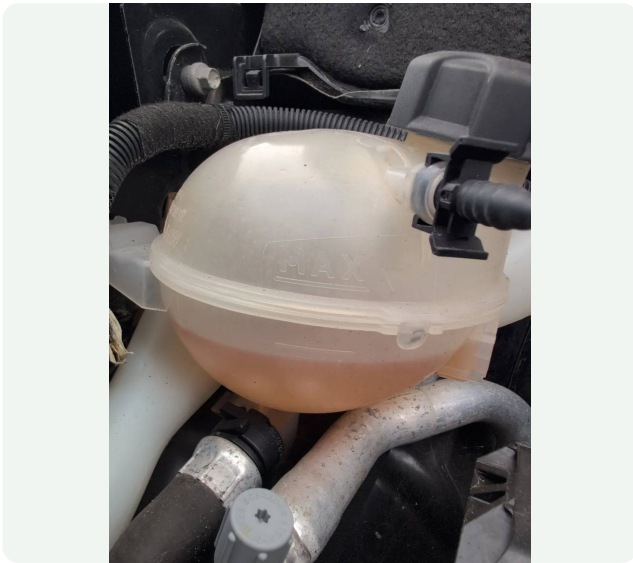
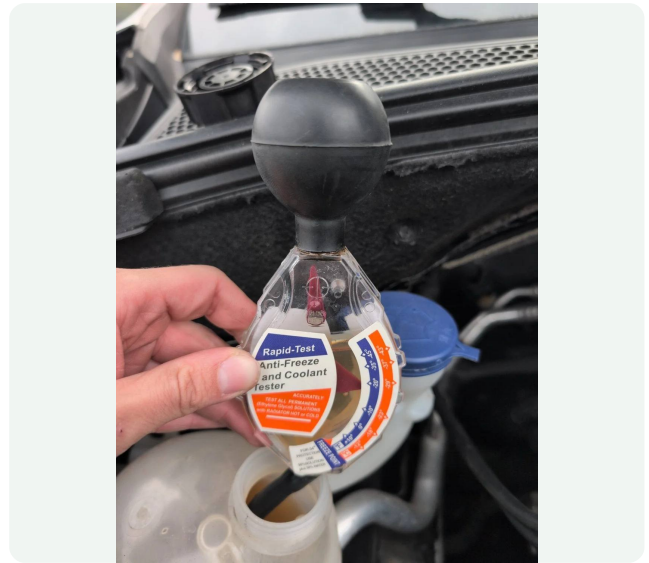
Coolant diluted and below the minimum level.

Coolant — Defect observed

Top up with undiluted coolant.

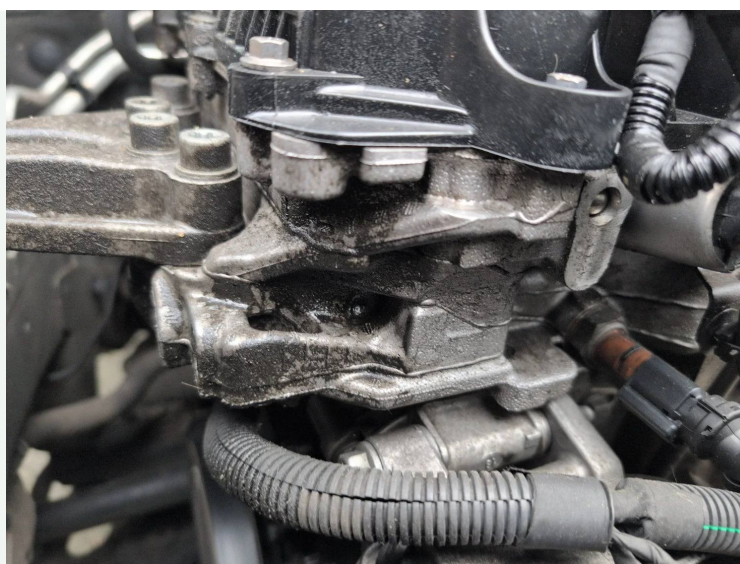
Photo 9 — Visible leaks

Oily traces on the engine.

Possible leak at the valve cover gasket or an engine seal.

Visible leaks — Monitor

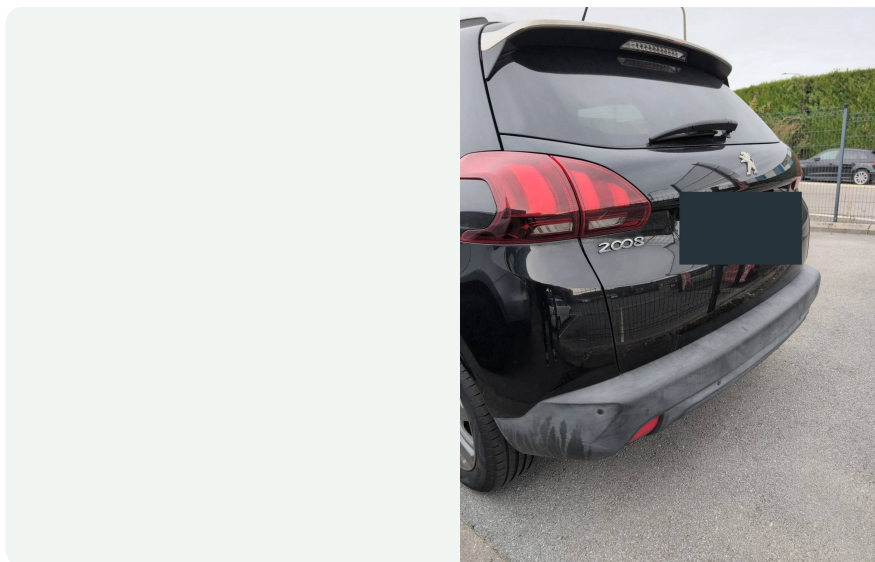
Photo 11 — Rear bumper

Discoloured bumper.

Rear bumper — Monitor

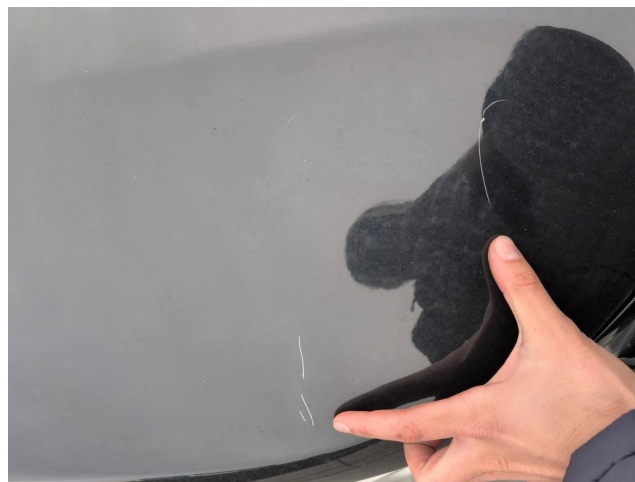
Visible scratches with paint and clear coat removed.

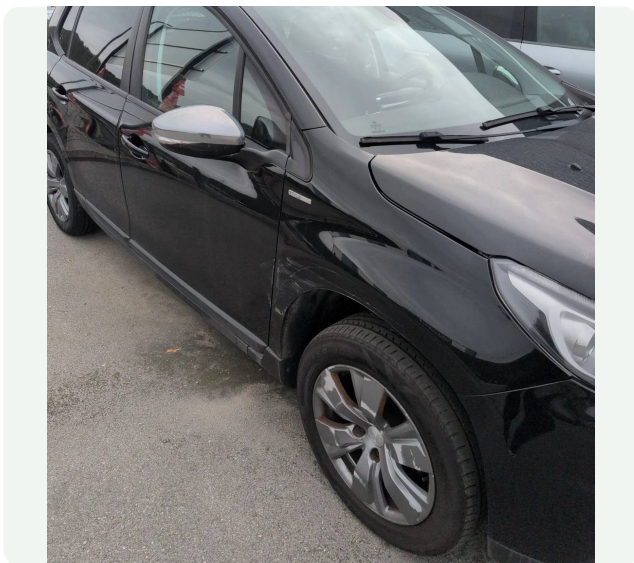
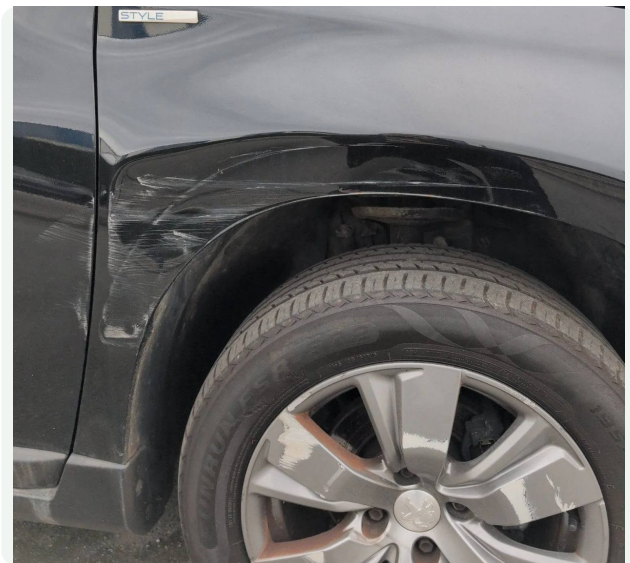
Scratches and a dent.

Front right fender — Defect observed

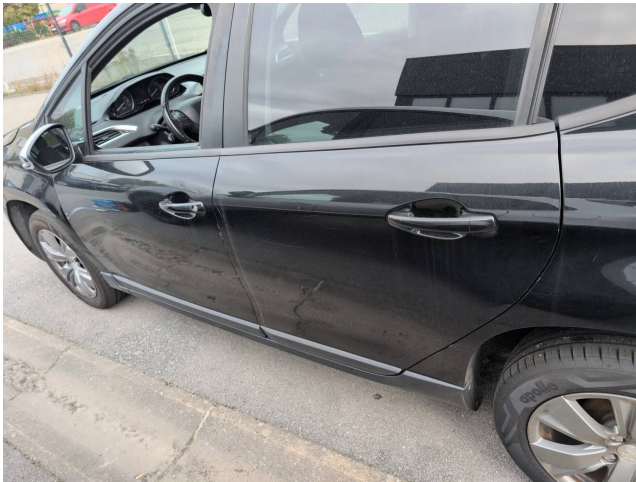
Some scratches.

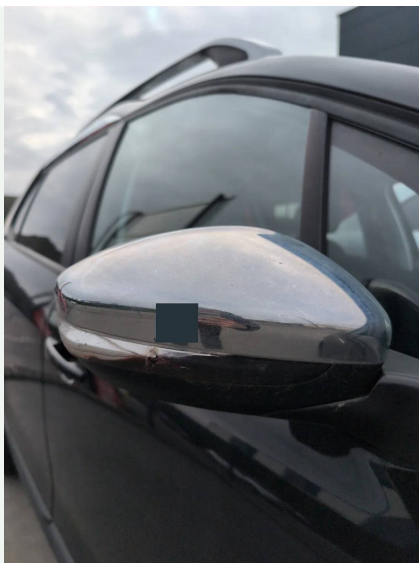
Photo 23 — Right mirror

Broken indicator lens.

Right mirror — Monitor

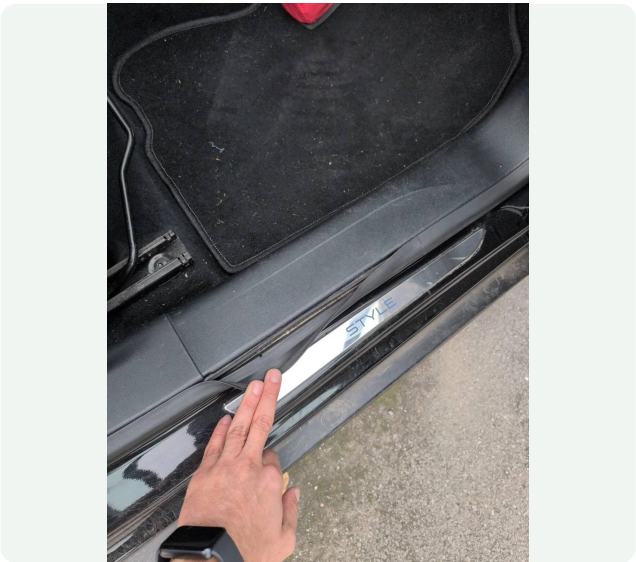
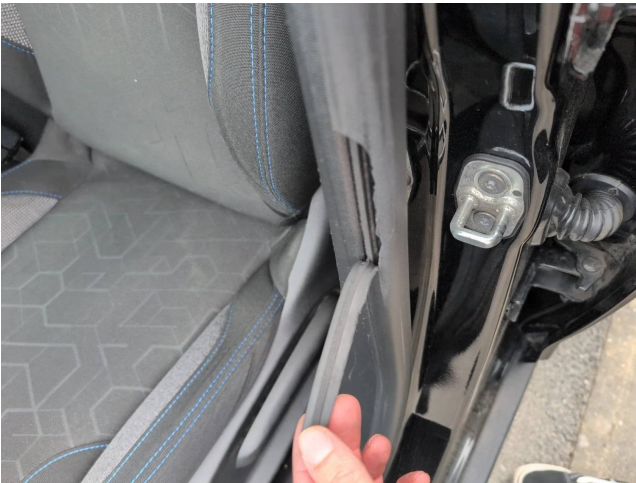
Torn seal on the passenger side.

Body seals — Monitor

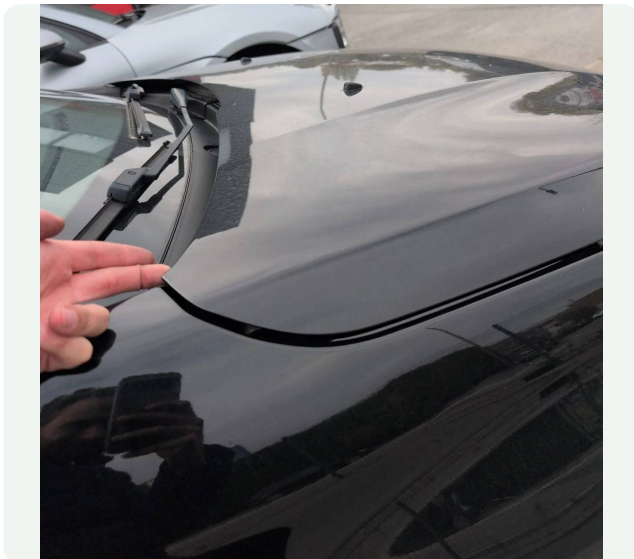
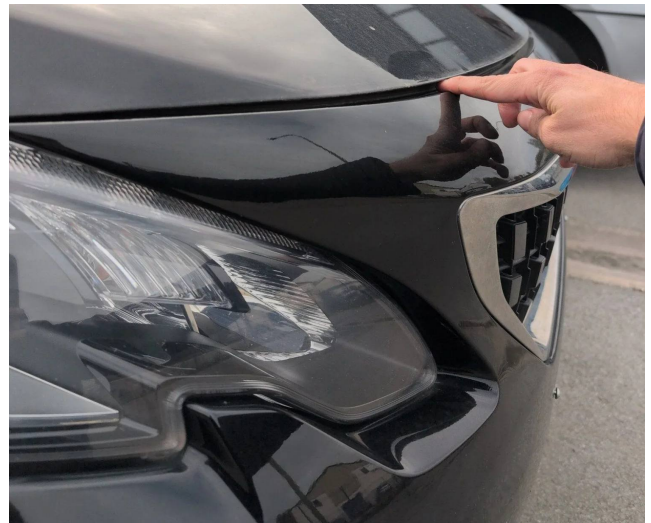
The bonnet, wings and front bumper are misaligned, strongly suggesting an impact.

Panel alignment — Defect observed

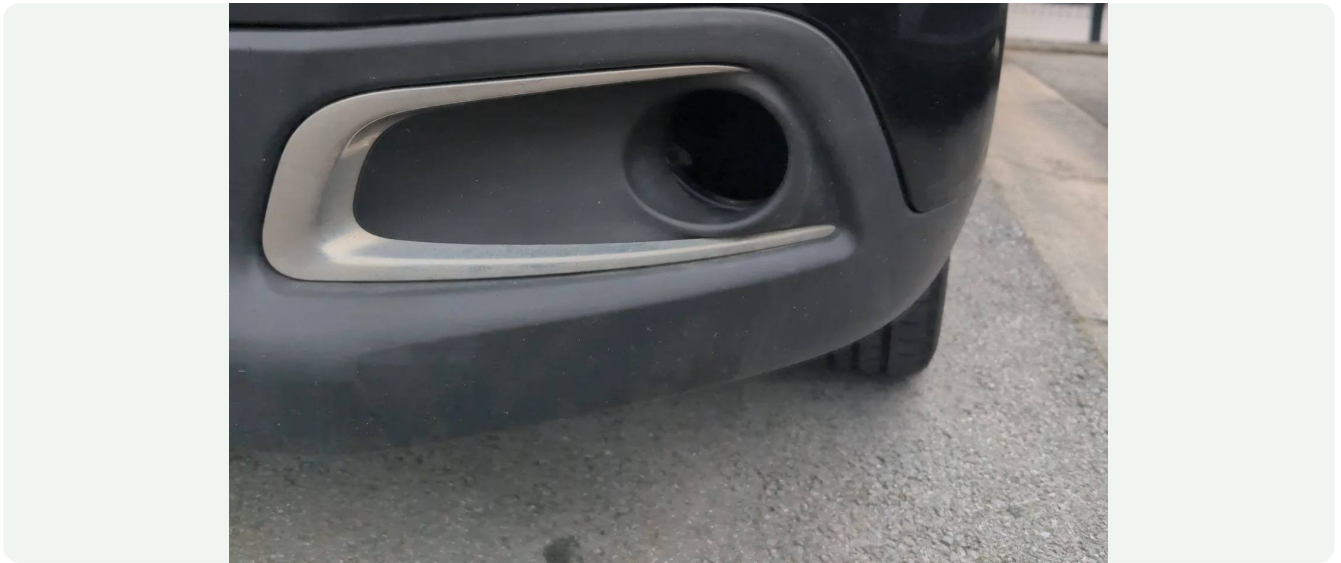
Photo 30 — Fog lights

Left fog light missing.

Fog lights — Defect observed

1. Replace the timing belt and carry out a full service with fresh fluids to establish a sound maintenance baseline.
2. Before the technical inspection, address at least the identified problems with the dipped headlights, registration plate lights, reversing lights and front fog lights.

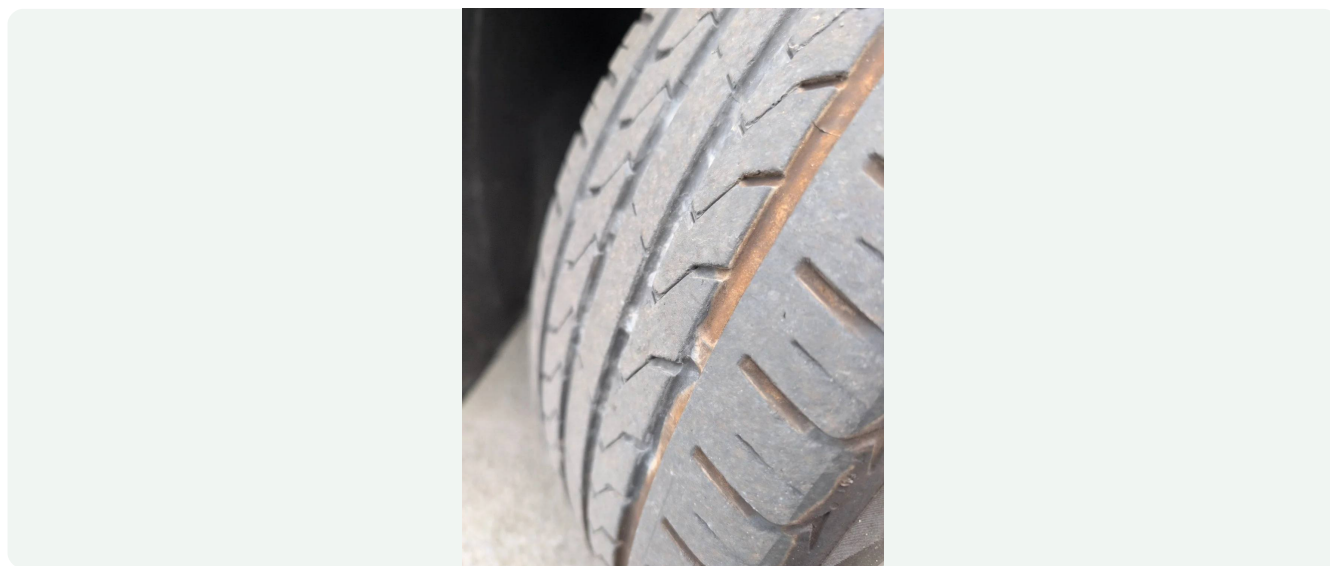
Photo 31 — Front left tyre

Estimated remaining tread depth: 10%.

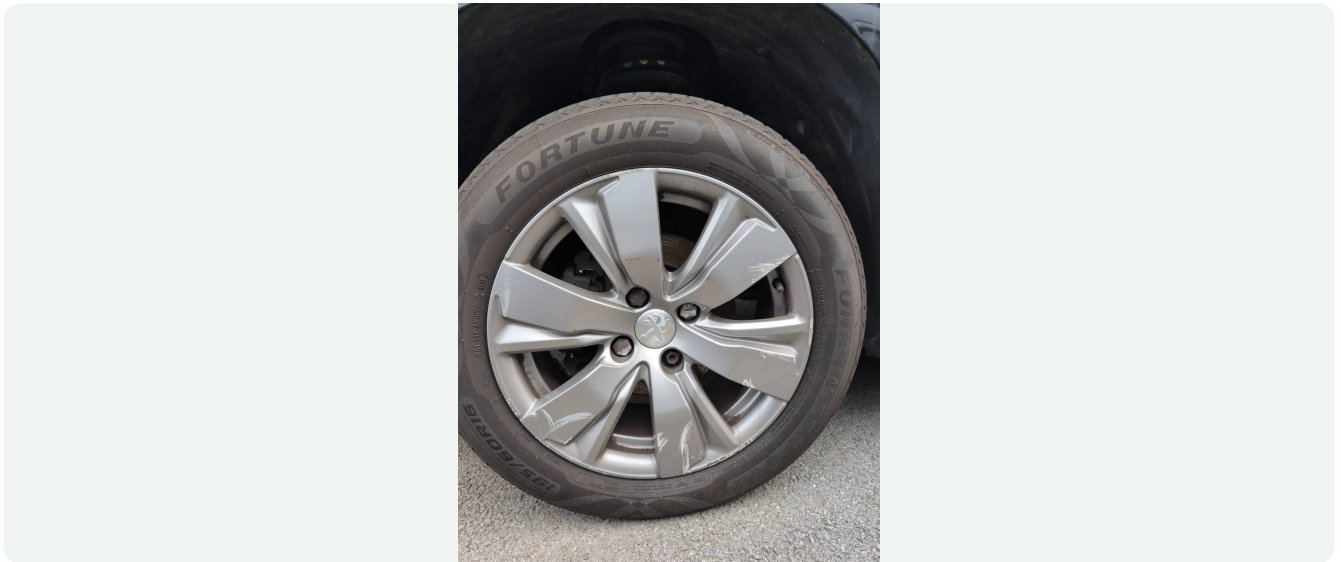
Photo 34 — Front left wheel

Some impact marks.

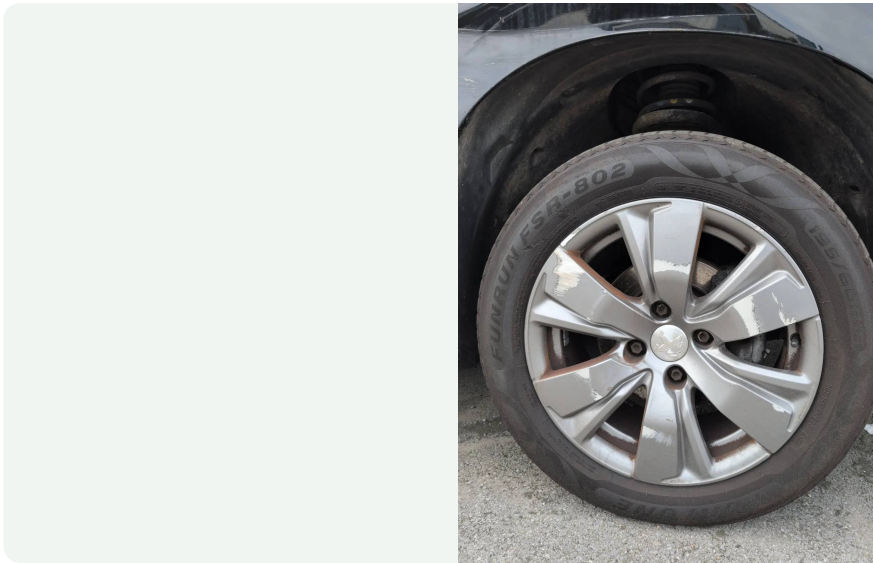
Photo 35 — Front right wheel

Heavily marked wheel rim.

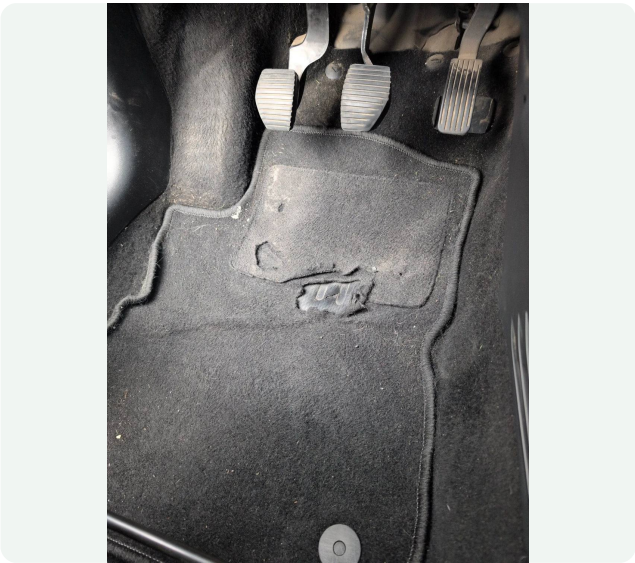
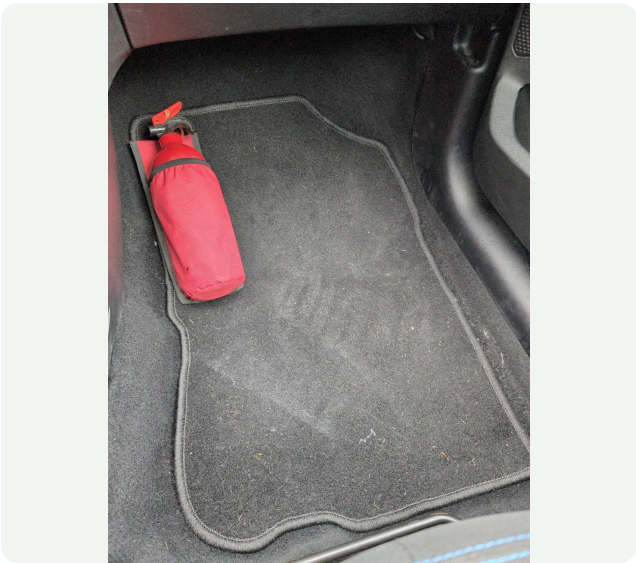
OBSERVATION  
Torn driver's floor mat.

Carpets and mats — Monitor
